Re: Request for Information

United Talmudic Academy of Kiryas Joel (UTA of KJ) - Bakertown Road, Kiryas Joel NY

A. INTRODUCTION

Photographs of United Talmudical Academy of Kiryas Joel on June 13, 2013. htner, P.E., Environmental Engineer, Nikon Coolpix P510, Kiryas Joel, NY
Photo ID		
No.	Photo Date	Photo Description
		View from the Highland Brook on the North Side. Roots from the trees
DSCN1297	6/13/2013	standing on the other bank are visible potentially due to a shift in the brook
		locations associated with construction activity.
DSCN1298	6/13/2013	Flow path channel under the silt fence. Not buried into the ground as required.
DSCN1299	6/13/2013	Video log showing a small turbid flow under the silt fence that is going into the Highland.
DSCN1300	6/13/2013	Photo showing a small turbid flow under the silt fence going into the Highland Brook.
DSCN1301	6/13/2013	Photo showing a small turbid flow under the silt fence going into the Highland Brook.
DSCN1302	6/13/2013	Rocks, rubble, and silt fencing around the property
DSCN1303	6/13/2013	Dried up flow of concrete visible on the left. Silt fencing and unnamed tributary of the Highland Brook on the eastern side of the site.

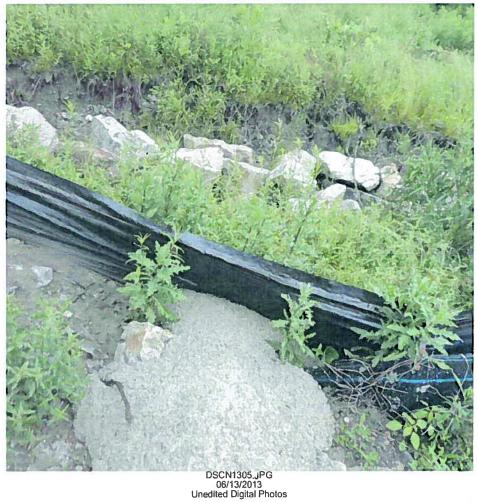
DSCN1304.JPG 06/13/2013

DSCN1304	6/13/2013	Dried up flow of concrete located on eastern side of the site near another unnamed tributary of Highland Brook.
DSCN1305	6/13/2013	Dried up flow of concrete. Another tributary is found beyond the silt fence on the east side of the site. The rocks are seen in the channel, water is seen in the channel.
DSCN1306	6/13/2013	Sediment/Soils overtopping the silt fencing into the unnamed tributary of Highland Brook with water/standing water on the eastern side of the site. Rocks from the construction site are clearly shown impeding any sort of flow.
DSCN1307	6/13/2013	Silt fence is improperly secured and is failing.
DSCN1308	6/13/2013	Flow path on the East side of the site that goes under the silt fence into the unnamed tributary of Highland Brook on the east side of the site.
DSCN1309	6/13/2013	Video showing flow path on the East side of the site that goes under the silt fence into the unnamed tributary on the eastern side of the site.

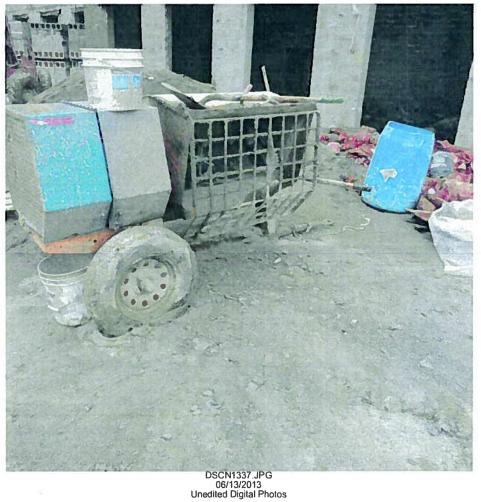
DSCN1336.JPG 06/13/2013

Photographs of United Talmudical Academy of Kiryas Joel on June 13, 2013. ntner, P.E., Environmental Engineer, Nikon Coolpix P510, Kiryas Joel, NY
Photo ID		
No.	Photo Date	Photo Description
DSCN1336	6/13/2013	The visible point of origin of the unnamed tributary on the west side. It starts from under the rubble located inside the silt fence perimeter of the work site. This water is slightly tinted reddish/brown.
DSCN1337	6/13/2013	Cement washed off in and around the cement mixing equipment. Empty cement bags are improperly disposed (seen on the ground in the photo background). There are visible signs of cement being carried off by surface runoff.
DSCN1338	6/13/2013	Empty cement bags alongside the building. Empty bags are exposed to stormwater. There are signs of cement being carried off by running water.
DSCN1339	6/13/2013	Cement washed off in and around the cement mixing equipment. Empty cement bags are exposed to stormwater. There are visible signs of cement being carried off by surface run-off

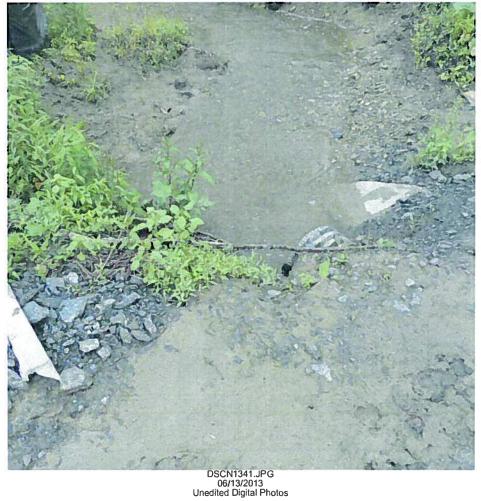
DSCN1340.JPG 06/13/2013

DSCN1340	6/13/2013	Multiple water runoff pathways are able to carry sediments under and around the silt fence into the flowing Highland Brook at the site entrance.
DSCN1341	6/13/2013	Signs of sediment being washed around the silt fence into Highland Brook are visible at the site entrance.
